ASD-TR-81-5016

INVESTIGATION OF SPATIAL DISORIENTATION OF F-15 EAGLE PILOTS

TECHNICAL REPORT ASD-TR-81-5016
Final Report 15 January 1980 - August 1980

DIRECTORATE OF EQUIPMENT ENGINEERING
AERONAUTICAL SYSTEMS DIVISION
AIR FORCE SYSTEMS COMMAND
WRIGHT-PATTERSON AIR FORCE BASE, OHIO 45433

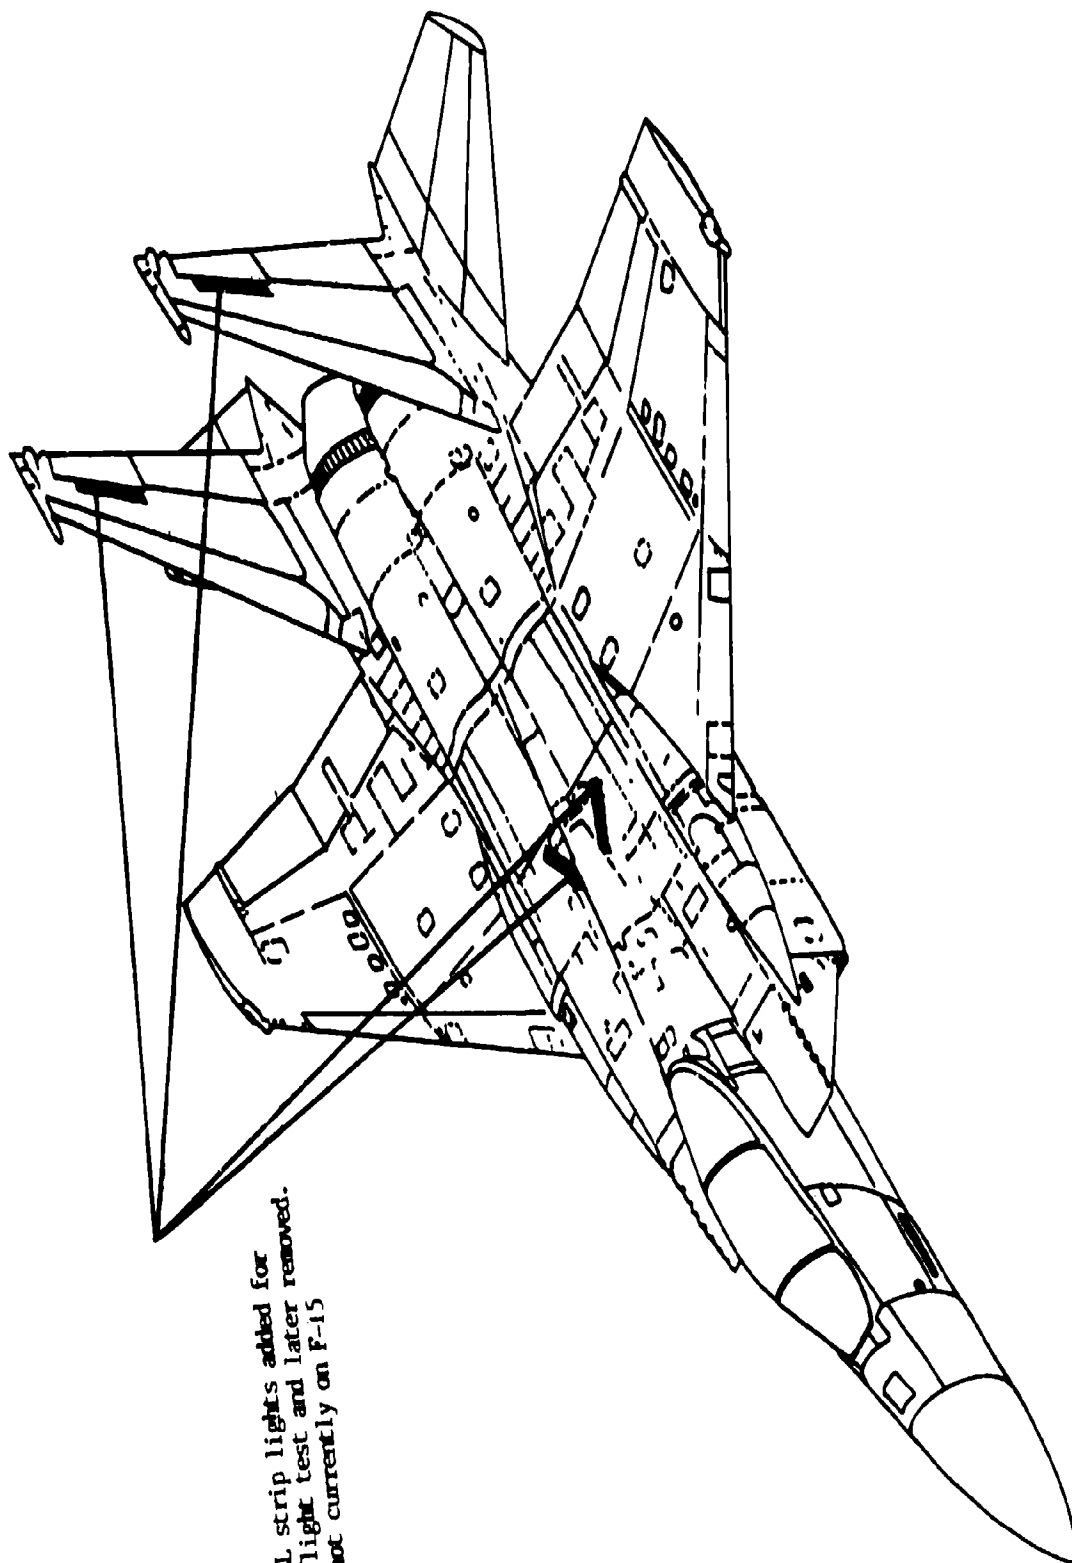
Figure 1

EL strip lights added for
flight test and later removed.
not currently on F-15

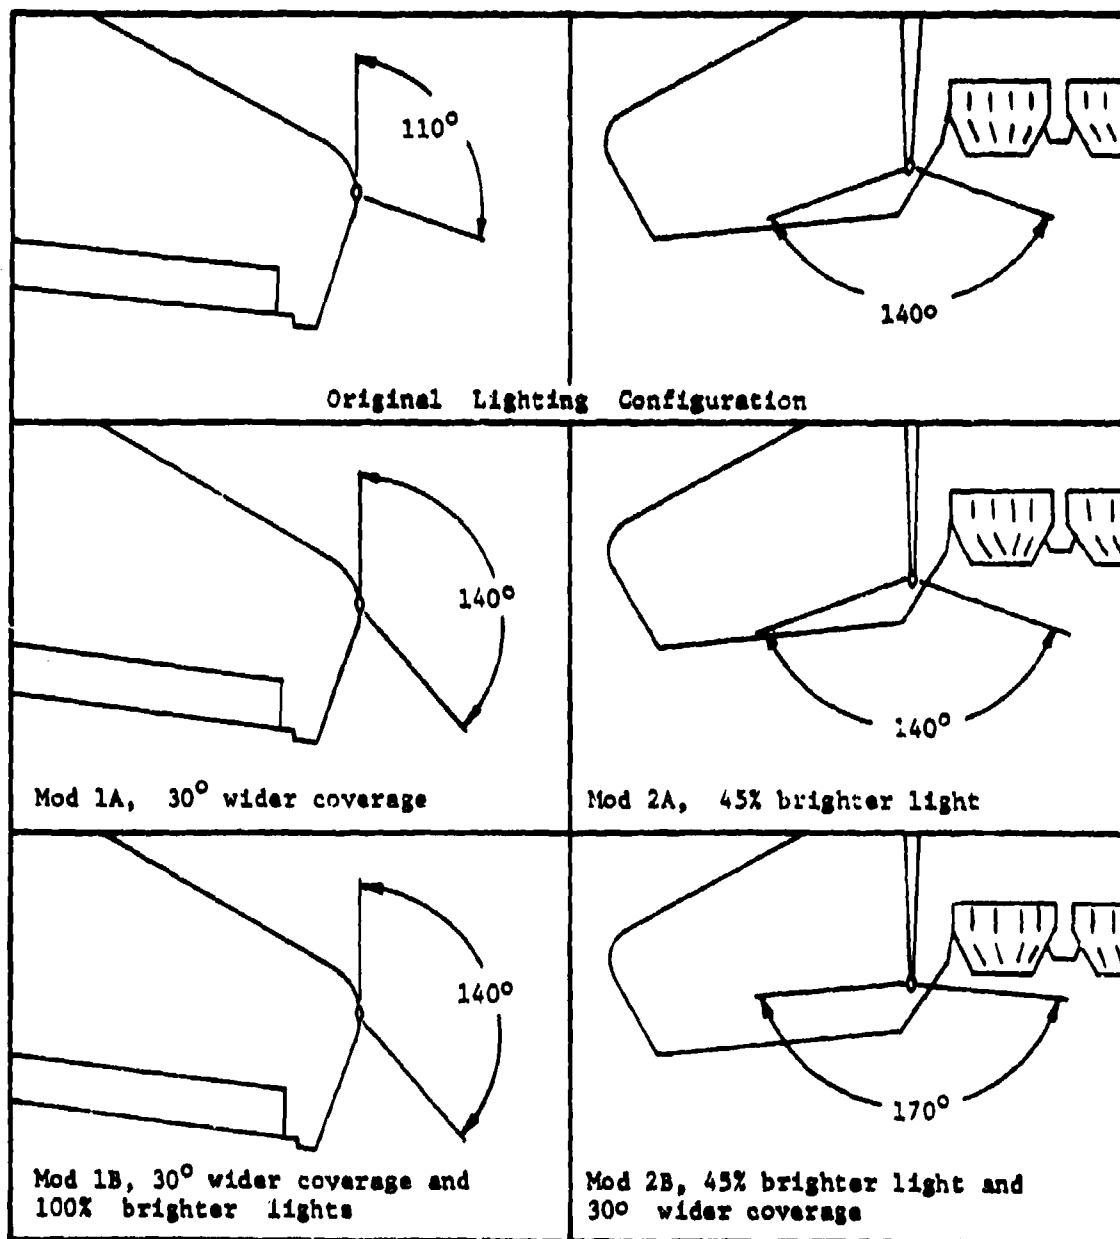
Figure 2
Modification of F-15 Exterior Lights

k. The results of the lighting modification flight test at Bitburg AB was that the lights were of little or no value to the pilots during join-up or formation flying. The final report from Bitburg AB stated that night rejoins are accomplished in visual meteorological conditions, and as long as the position lights and anti-collision lights were operating normally, there was no problem in acquiring the lead aircraft early in the rejoin phase. During formation flight in either night or day weather, the modified position lights were of little value. The pilots, however, indicated a need for additional formation lights (electroluminescent strip lights) or flood lights on the vertical stabilizer.
